Geotechnical
Environmental and
Water Resources
Engineering

April 15, 2005
Project 050030

**Subject: Geotechnical Design Study
Simpson Road Bridge Rehabilitation
Saco, Maine**

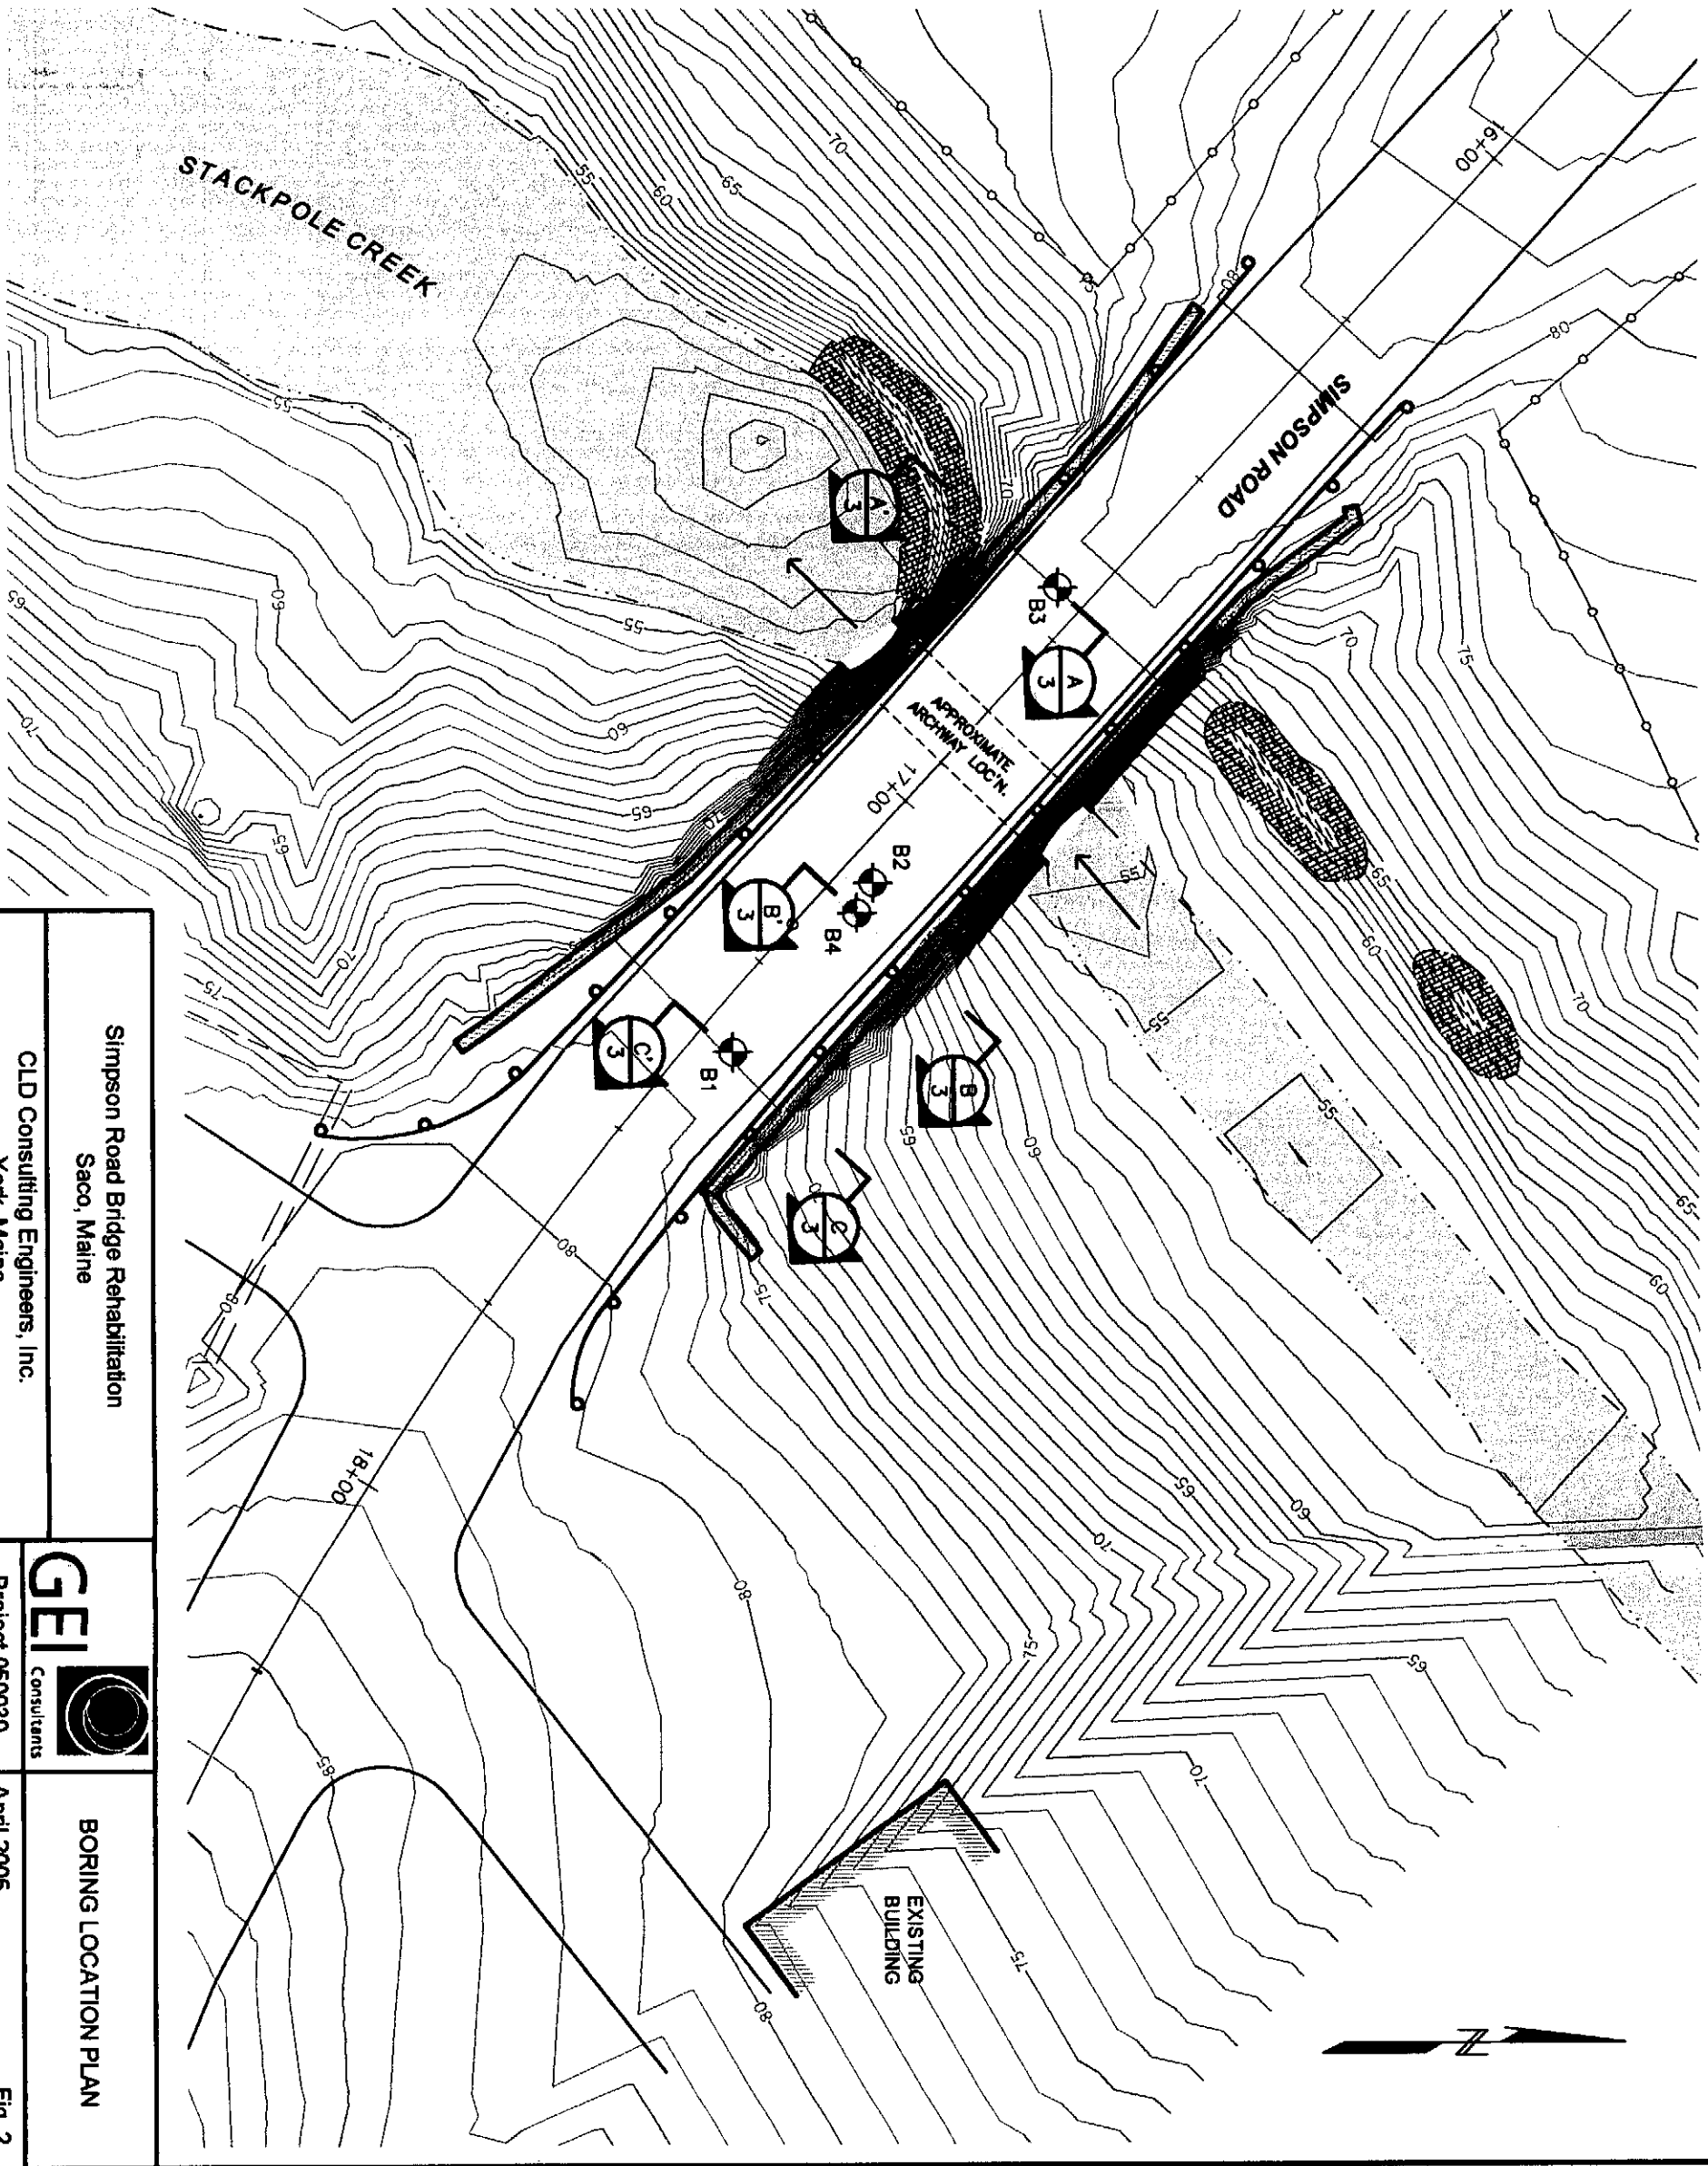
| Project 050030 | | April 2005 | Fig. 2 |

GEI engaged Maine Test Borings, Inc. of Brewer, Maine to drill borings at the site. Four borings (B1 through B4) were drilled at the locations shown on Figure 2 on January 10 through

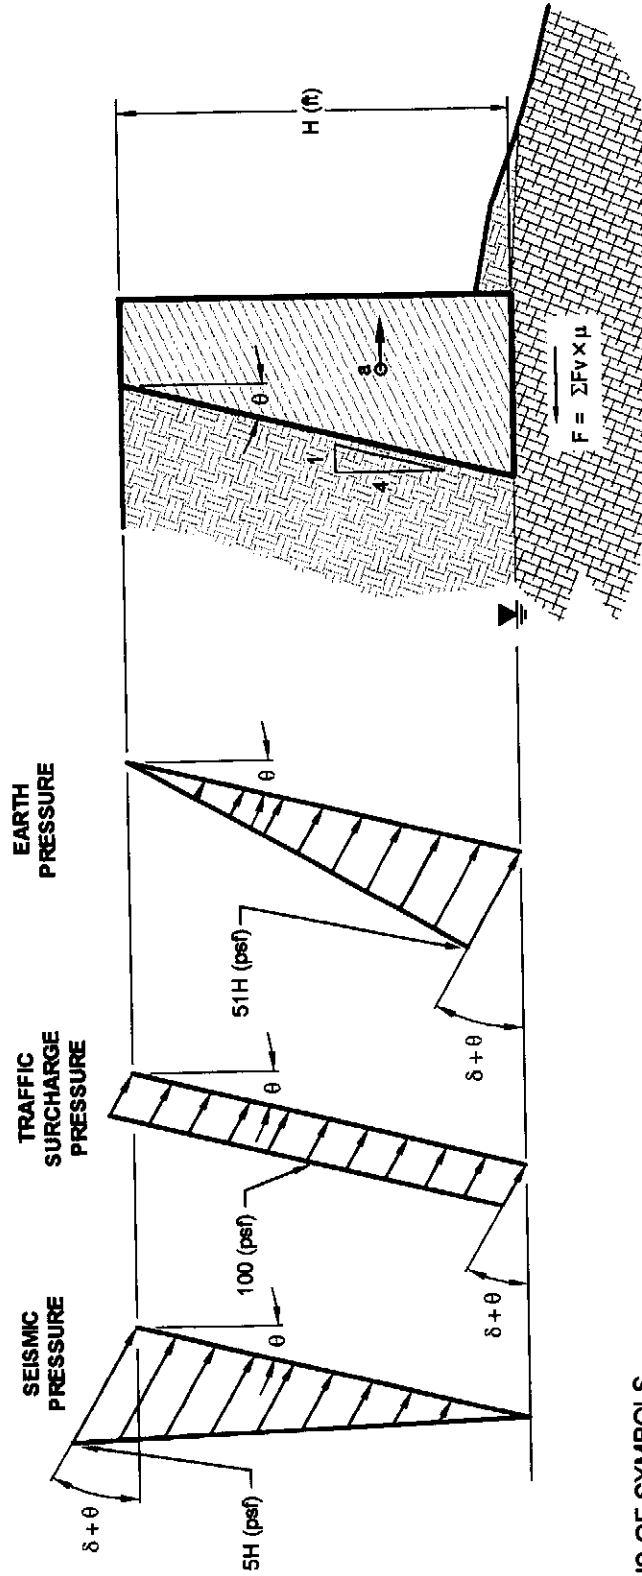
EARTH AND WATER
PRESSURES FOR NORMAL
AND EARTHQUAKE LOADING
CONDITIONS

- c) Earth and Hydrostatic Water Pressures: Our recommended earth, surcharge, and hydrostatic water pressures for use in the stability analyses are provided on Figures 4 and 5.

- i) For the normal loading condition, the earth pressure behind the walls should be estimated assuming the groundwater level in the backfill is low enough that no differential water pressure acts on the wall. For this case, the active pressure should be used in conjunction with the traffic surcharge pressure, as shown on Figure 4. The active earth pressure was estimated assuming an internal friction angle of 30° for the backfill, an interface friction angle between the wall and backfill of 15° , and a soil total unit weight of 120 pcf. The traffic surcharge pressure was estimated assuming an equivalent 2-foot-thick layer of soil.

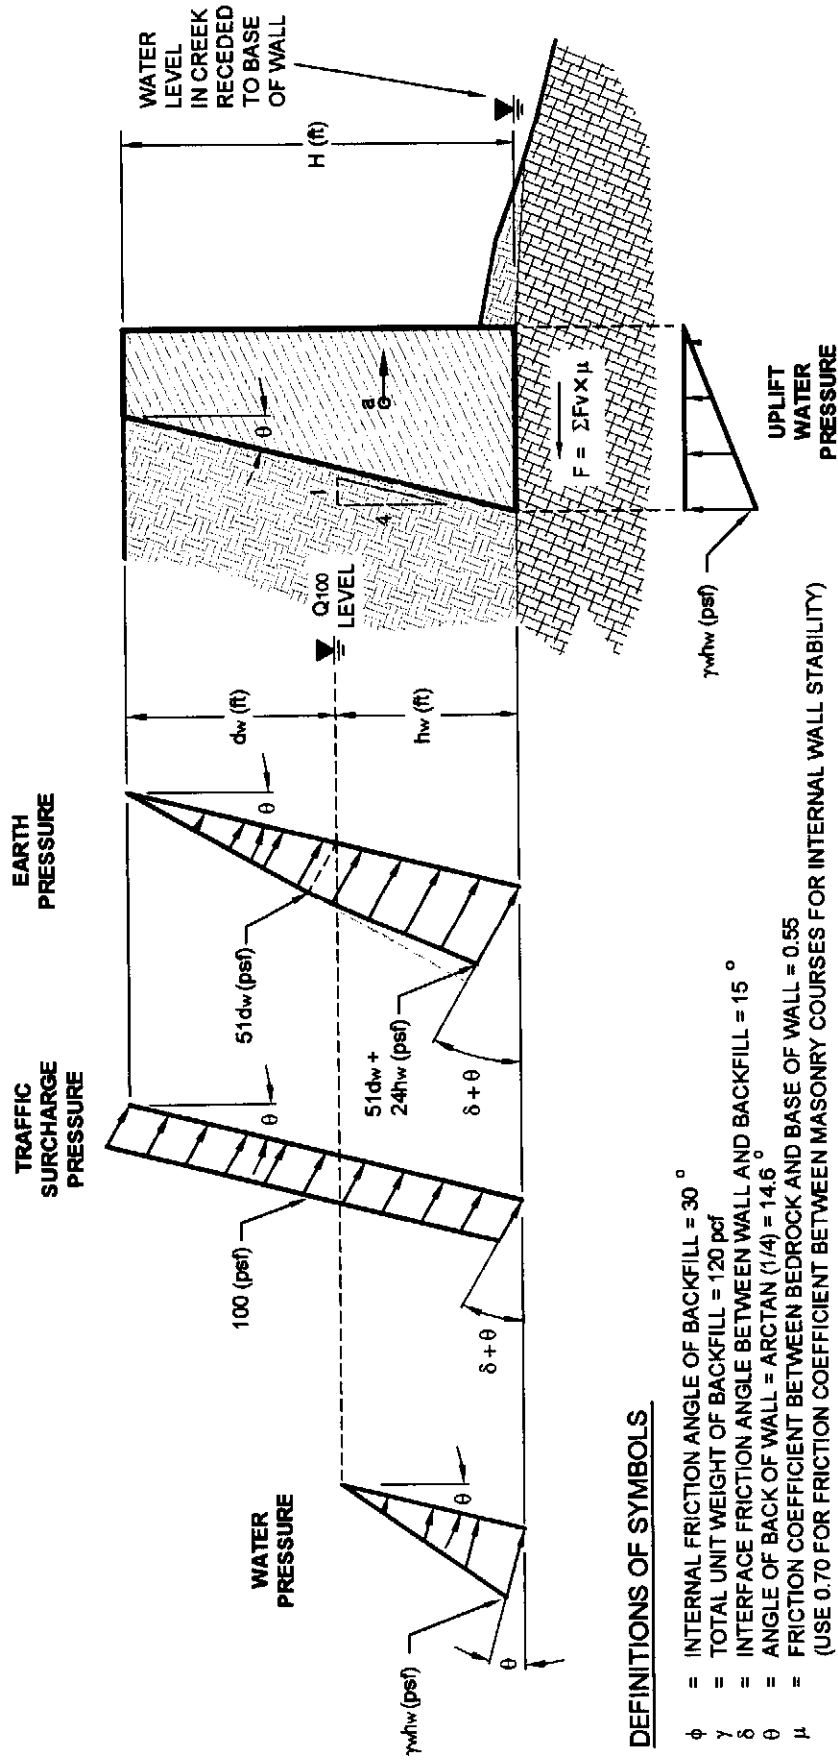
| GEI Consultants | Simpson Road Bridge Rehabilitation Saco, Maine | EARTH AND SURCHARGE PRESSURES FOR RAPID DRAWDOWN CONDITION |

- ii) An extreme loading condition in which a portion of the backfill is assumed to be saturated should also be analyzed. Partial saturation of the backfill would occur during storm events when the surface water in Stackpole Creek temporarily rises against the walls of the bridge, and then recedes more quickly than the water in the backfill can drain through the masonry, causing a rapid drawdown condition. The differential water pressure acting on the walls during the rapid drawdown condition depends on the rate at which the water infiltrates and saturates the backfill, and then drains from the backfill as the surface water level recedes. Estimation of the differential water pressure would require a transient flow analysis that is beyond the scope of this study. In lieu of a transient flow analysis, we recommend that the differential water pressure be estimated assuming that the groundwater level in the backfill remains at the water level associated with the 100-year storm event (elevation 68.2 feet, project datum), while the surface water in the creek quickly recedes. Earth and water pressures for this condition are provided on Figure 5. Uplift water pressure was estimated assuming the pressure decreases linearly from the heel to the toe of the structure.

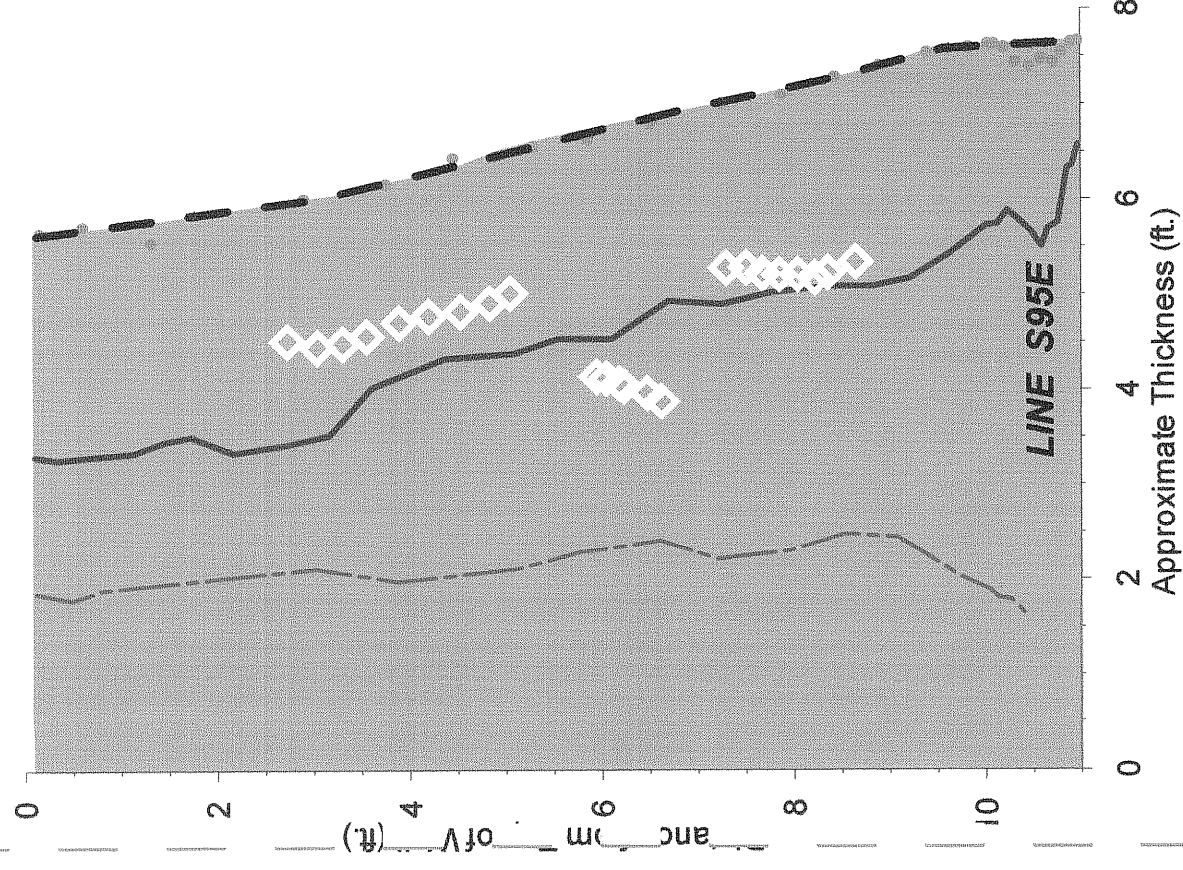
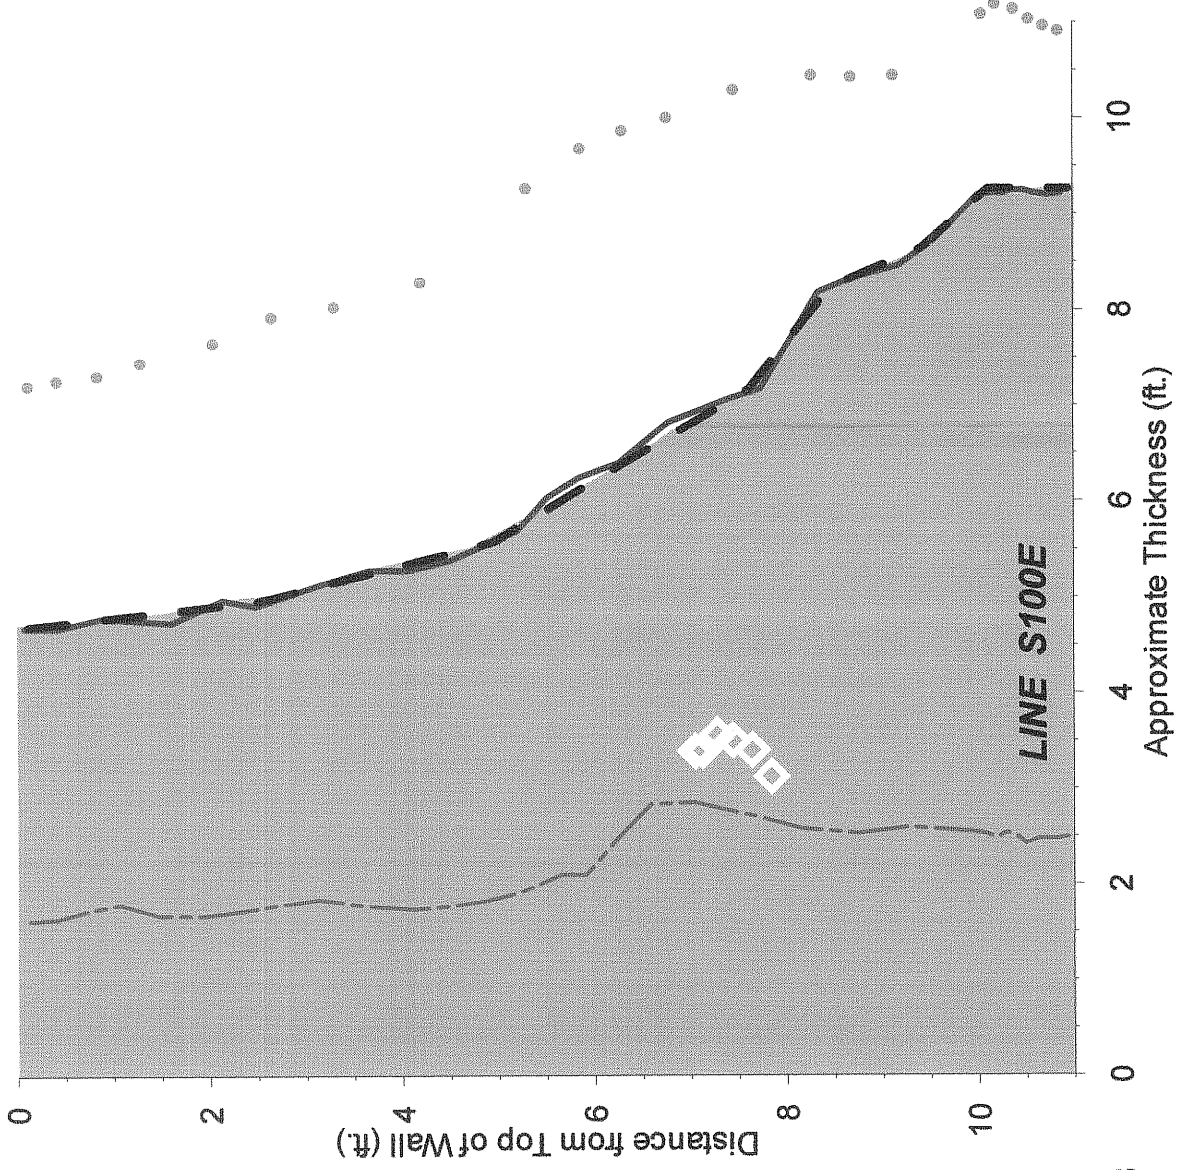
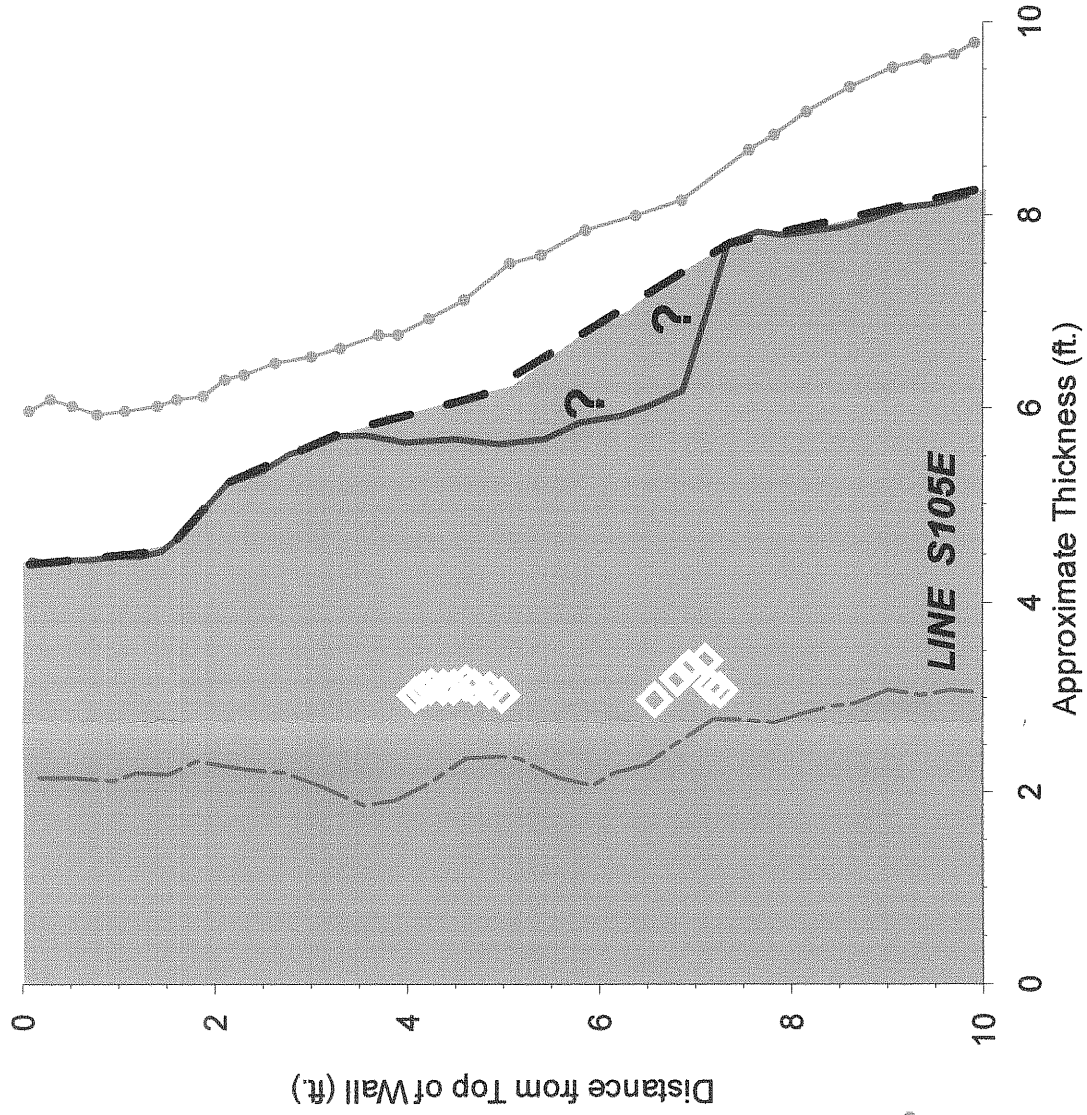
FIGURE 5
INTERPRETED GPR RESULTS
SOUTHEAST QUADRANT (Q2)
SIMPSON ROAD BRIDGE
SACO, MAINE
Prepared for
GEI CONSULTANTS
APRIL 2005

Variations in bridge wall thickness in the southeast quadrant are similar to what is found in the southwest quadrant but the thickness of the wall at the top appears to be greater in the southeast. The maximum thickness of the wall at the base along Lines S95E through S105E is about 8 to 9 feet, again, similar to that observed in the southwest quadrant.
